REPAIRING ALUMINUM WIRING

Publication 516

ALUMINUM WIRING

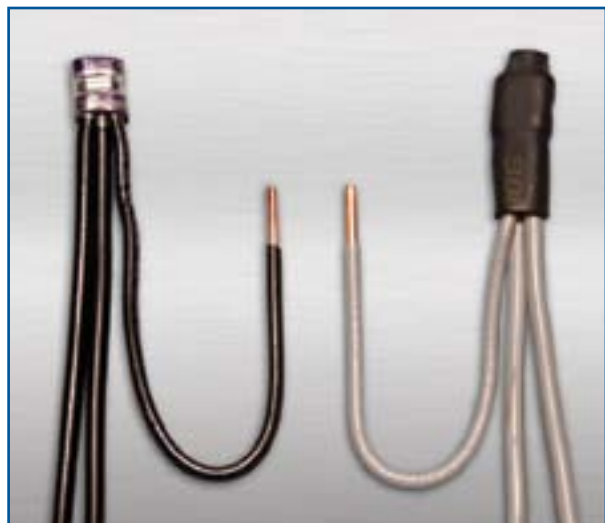
Recommended COPALUM Connector Repair

The COPALUM connector is a specially designed system that includes a metal sleeve intended to be installed only with a dedicated power tool and crimping die to make a permanent connection, that is, in effect, a cold weld (the precision dies in the COPALUM tool compress the connector and wires using upwards of 10,000 pounds of force, as required to make the permanent aluminum wire connection).

The tool is shown in the illustration below. An insulating sleeve is placed around the crimp connector to complete the repair. The copper wire pigtail is then connected to the switch, receptacle, or other termination device. An example of a repaired receptacle outlet is also illustrated below.

Only electricians who are trained by the manufacturer to use the tool properly are authorized to install COPALUM connectors. CPSC staff emphasizes that this training is necessary to ensure that the electrician uses the careful, professional workmanship and thoroughness required to make the crimp connector repair safe and permanent.

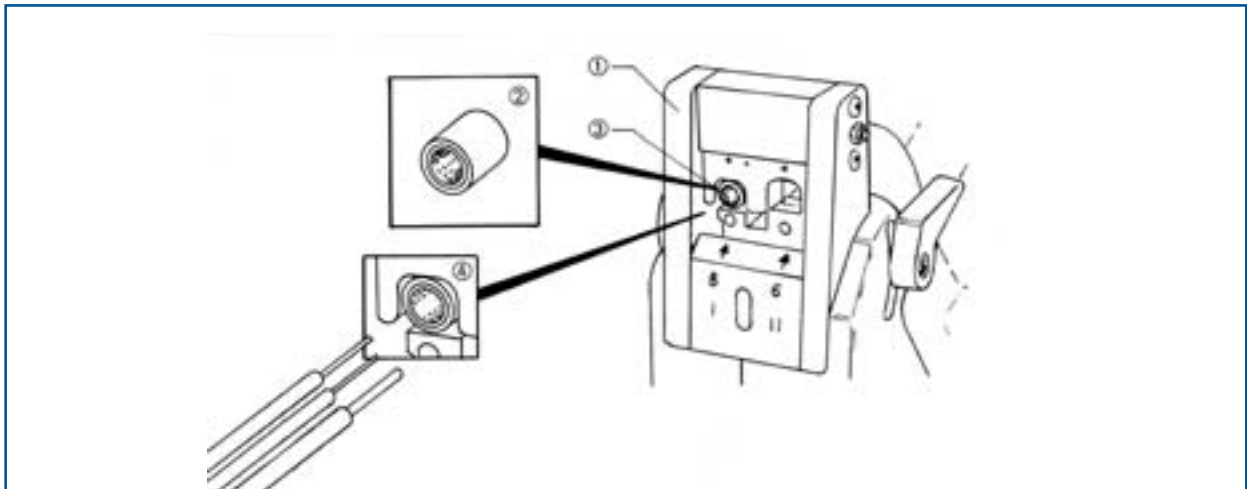
COPALUM Crimp Connector and its Specialized Installation Tooling

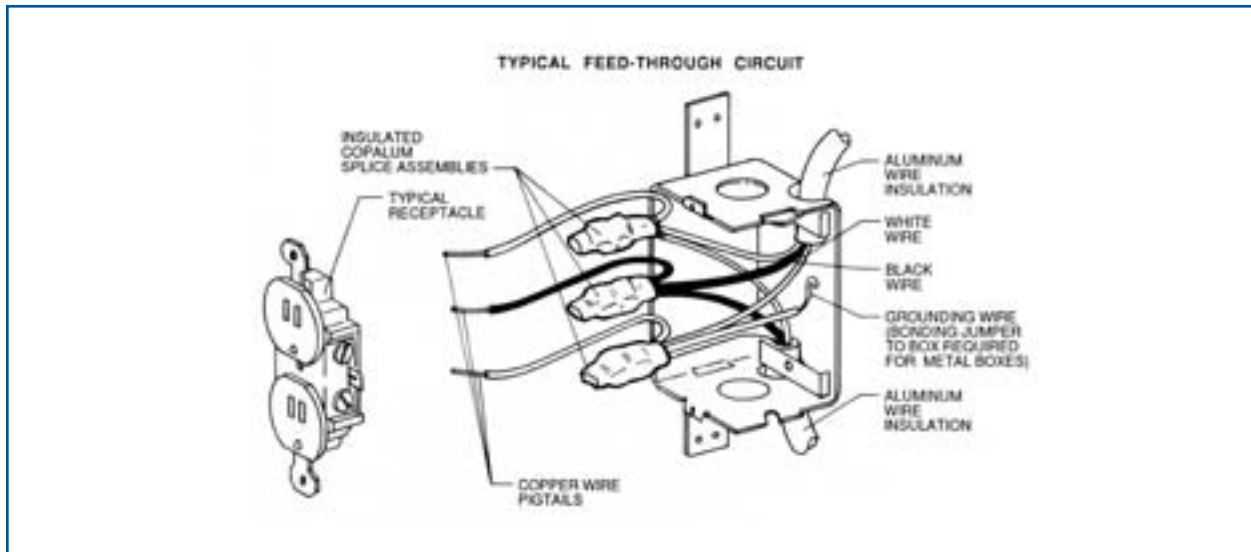
As an alternate to rewiring with copper, CPSC recommends attaching a short section of copper wire to the ends of the aluminum wire at connection points (a technique commonly referred to as “pig-tailing”), using a special connector named COPALUM to join the wires. CPSC staff considers pig-tailing with a COPALUM connector to be a safe and permanent repair of the existing aluminum wiring. The repair should include every connection or splice involving aluminum wire in the home, including outlets, dimmers, switches, fixtures, appliances, and junction boxes. The repaired system, with short copper wire extensions at every termination throughout the home, permits the use of standard wiring devices, including receptacles and switches.

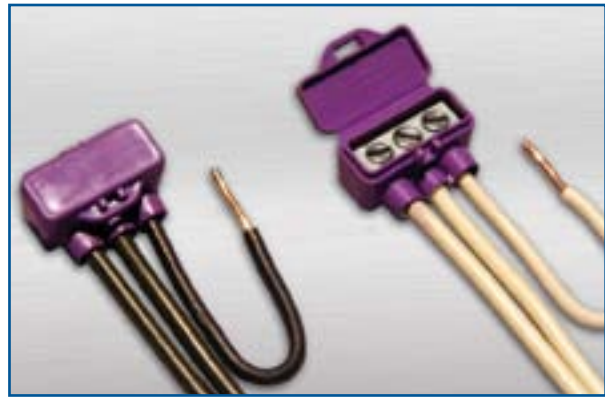
CPSC staff recognizes that copper replacement may be cost prohibitive and that the COPALUM repair may be unavailable in a locality. Based upon an evaluation that was, in part, CPSC supported,⁵ consumers are advised that, if the COPALUM repair is not available, the AlumiConn connector may be considered the next best alternative for a permanent repair. This repair method involves pigtailing using a setscrew type connector instead of the COPALUM crimp connector in the repaired connections.

The AlumiConn Connector

The AlumiConn connector has performed well in initial tests, but is too new to have developed a significant long-term safe performance history as the COPALUM repair. The repair should be conducted by a qualified electrician because careful, professional workmanship and thoroughness are required to make the AlumiConn connector repair safe and permanent.

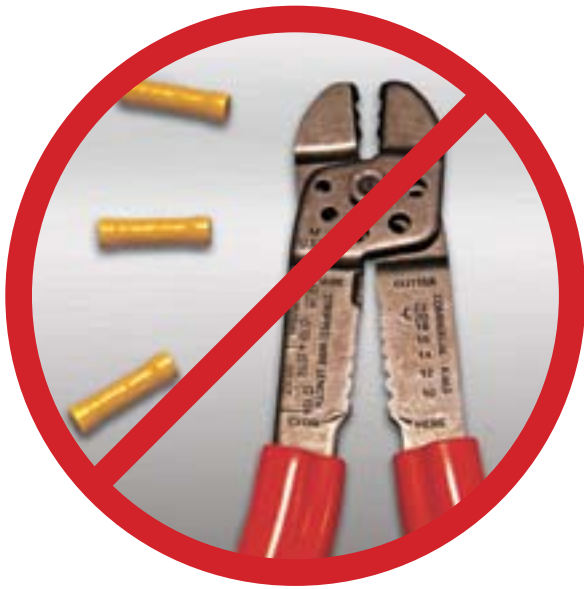
No other crimp connectors have been evaluated for connecting copper and aluminum conductors. CPSC staff strongly recommends against their use as a repair method.

Do Not Use Common Hand-Crimped Connectors with Aluminum Wire

There are many other brands and types of crimp connectors – including those intended to be installed with a pliers-type of handtool – which are readily available to consumers at common retailers.

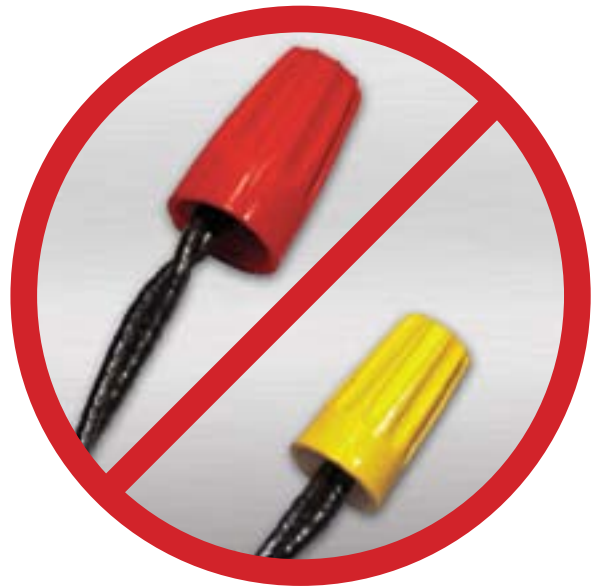
The first temporary repair involves pigtail with a twist-on connector. The effectiveness of “pigtail” using twist-on connectors has been evaluated by CPSC staff. In CPSC-sponsored laboratory testing and life tests, substantial numbers of these connectors overheated severely.

“Pigtail” with Twist-on Connectors Is Not a Recommended Repair

of twist-on connectors with aluminum wire. It is possible that some pigtail “repairs” made with twist-on connectors may be prone to even more failures than the original aluminum wire connectors. Accordingly, CPSC staff believes that this method of repair does not solve the problem of overheating present in aluminum-wired branch circuits.
